## CASE STUDY: MCC UPGRADE BOOSTS UPTIME IN MINING

Spark Power partnered with a leading mining and fertilizer facility in Saskatchewan to address recurring downtime and operational inefficiencies caused by an aging Motor Control Center (MCC). The existing system's outdated controls and lack of fault visibility created delays in troubleshooting, reduced operator productivity, and increased maintenance costs.

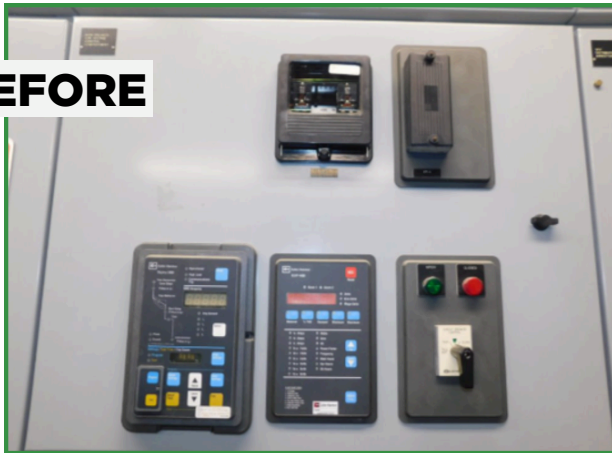
**BEFORE**

- ✓ Outdated MCC slowed operator response.
- ✓ No fault indicators, delaying troubleshooting.
- ✓ Unreliable legacy controls.
- ✓ Hard-to-source replacement parts.

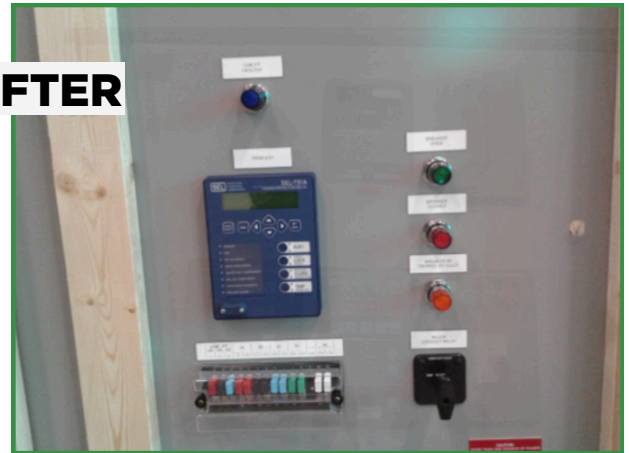
**AFTER**

- ✓ Installed modern fault indicators for quick fault detection.
- ✓ Simplified MCC layout to improve operator efficiency.
- ✓ Upgraded to reliable, CSA/UL certified industrial controls.
- ✓ Standardized on readily available replacement parts.
